# EXHIBIT A

## Executive Summary

**East Valley Bus Operations and Maintenance Facility**  
2009 Facility Addition Feasibility Analysis  
Tempe, Arizona

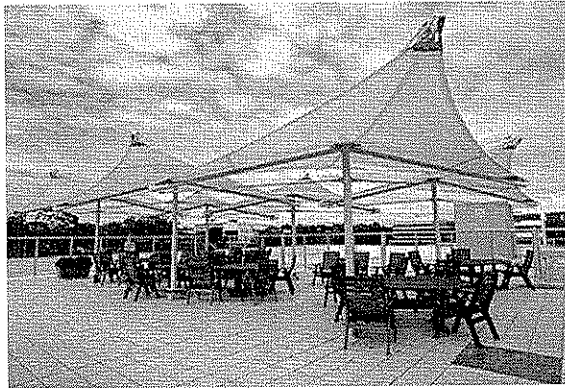
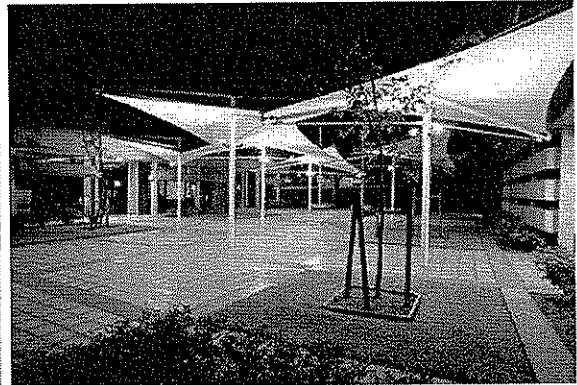
Since this area has a southern exposure, the east end is already enclosed by a solid concrete wall, and the west end is shielded by an existing fabric canopy, the most effective shade technique is the addition of horizontal elements. The space is between 17' and 19' wide, partially occupied by landscaping. Therefore, the design team's opinion is that a pre-fabricated fabric canopy is the best solution. Fabric would match the existing canopy elements on the building, sizes that would fit in the space comfortably are available, and the canopies are pre-engineered so the city could save those costs. A variety of companies make these types of canopies, and below in Exhibits 11A and 11B are two examples from Birdair, Inc.
